Assessment of Microbial Quality of Surface Water Sources of Luvuvhu River Catchment, South Africa

Mailula M.A. and Gumbo JR

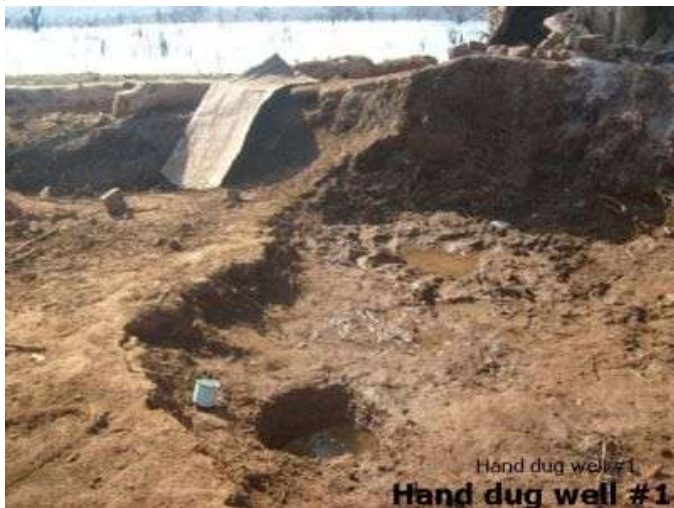
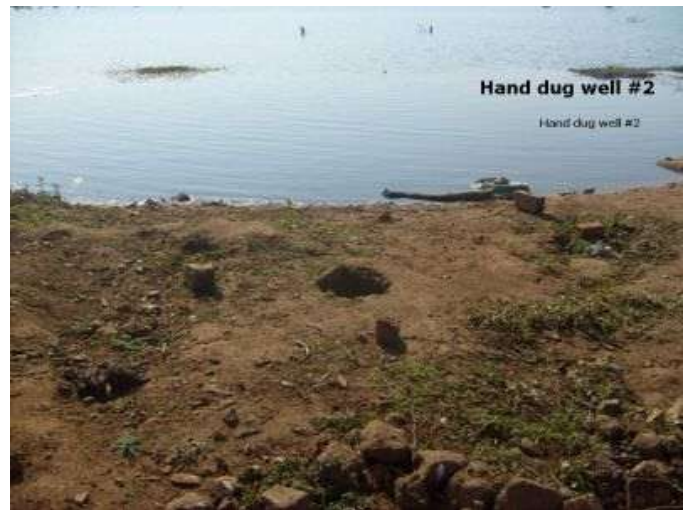
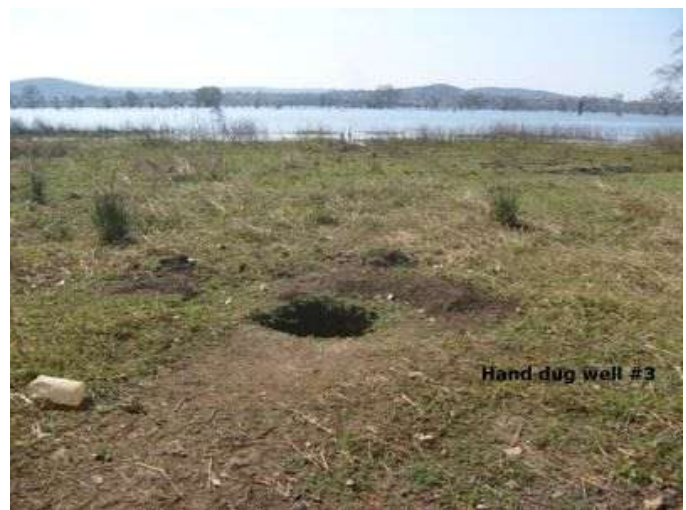
Fig 2: The location of hand dug wells along Nandoni dam

The microbial quality of the hand dug wells (Figure 2) and Nandoni Reservoir water was different, with the latter was highly contaminated than that from the hand dug wells (Table 7).

Thus, to improve the microbial quality of the drinking water, some of the rural communities have resorted to hand digging of wells (Figure 1).

The hand dug wells are also commonly used in rural areas and are dug inside a river channel or along a river bank [11]. The river sand is then used to filter out pathogens as the water fills the open space inside the hand dug well [12]. The wells, which

are usually quite shallow, typically 0.3 m to 0.6 m deep, are very important to rural communities, especially in areas where surface water is scarce. Nonetheless, these wells are easily prone to contamination. The major objective of the study was to assess the microbial quality of surface water sources in both the Luvuvhu River catchment and hand dug wells that are dotted along the Nandoni Dam, Vhembe district of the Limpopo province of South Africa.
