Mapping the Environmental Damage of “Erzeni” River using GIS Technology. The Impact of the High Way Construction. *Case study Bërzhitë-Vaqarr*

Prof. as. Dr. Edmond HOXHA

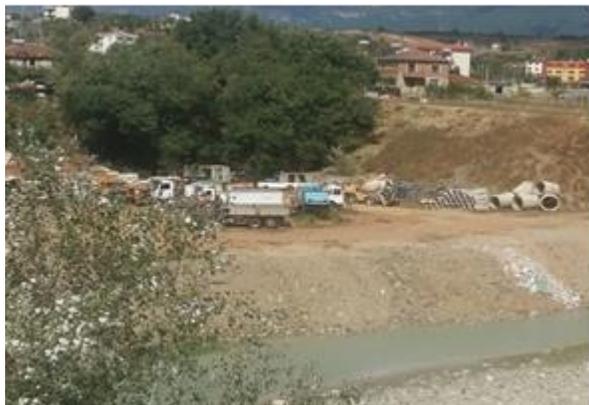
This happen because as a result of the need for the development of the construction industry. This type of exploitation is done without criteria and more than the capacity of this river. The consequences of this exploitation are the change of ecosystem and the increase of floods; lowering the river bed due to erosion of the bed; erosion of side edges and agricultural lands; the great pollution of the river bed; lowering the level of groundwater, which results in the failure of some wells; as well as the creation of small swamps along the riverbed. (Fig.2).

Fig.2 Environmental damages because of Exploitation of River inertias

- Stop any activity on the river bed
- Construction of retaining walls of soil deposits in order not to flow into the river;
- Do not allow garbage or landfills to be deposited in the river bed;
- Immediate prohibition of discharges of contaminated water into the stream without filters;
- Rehabilitation of damaged areas, planting trees etc.;
- Establishment of waste collection bins in residential areas;

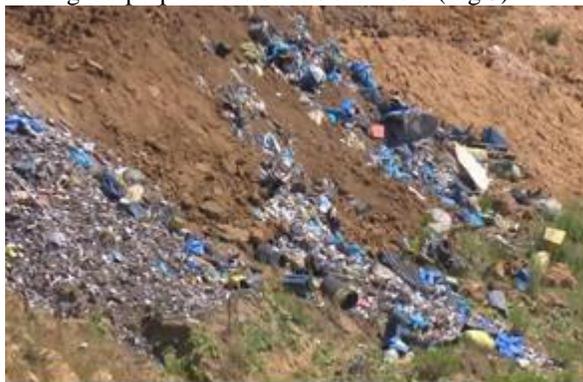
This phenomenon is the cause of irresponsible behavior of some companies that throw hospital waste on the banks of the Erzeni River. This phenomenon has been condemned by the community and the Government has taken measures condemning the perpetrators of this situation. (Fig.3)

Fig.3 Disembark of hospital waste.

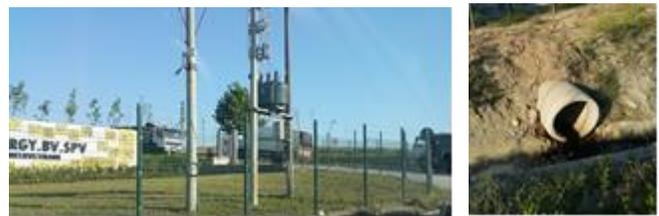
The most flagrant case of this phenomenon is the spillage of wastewater from the largest Landfill of Sharra in the city of Tirana where the wastewater flows from the land surface and end up in Erzeni River. These polluted waters also lead to the death of river fish, and other damages. (Fig.3)

Fig.3 Discharge of Sharra's landfill wastewater into the river [Photo: Mariglen Kume]

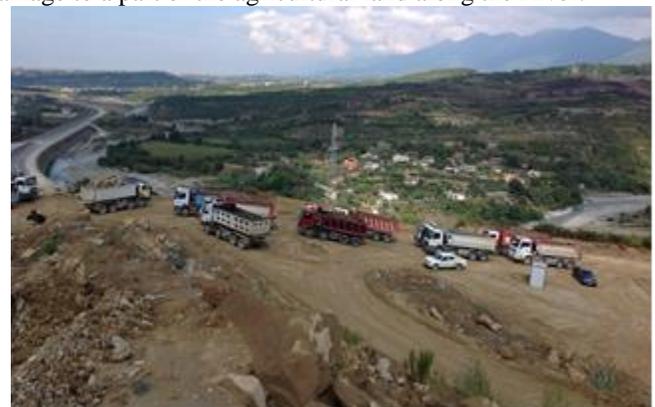
The Tirana-Elbasan highway has begun to be built in 2011, currently it is in operation but some special parts are still under construction due to landslide problems. The construction of this highway besides the positive sides has also brought negative ones, especially in the field of environment. The main impacts on the environment of this highway concern mainly the deposition of soils along the banks of the Erzeni River and the damage to a part of the agricultural land along the River.

Fig.4 view of the highway Tirana-Elbasan works

- Cleaning of irrigation channels;
- Cleaning of highway water discharge channels;
- Removal of all old machinery and waste deposited along the Riverbank;
- Enforcement of environmental legislation.

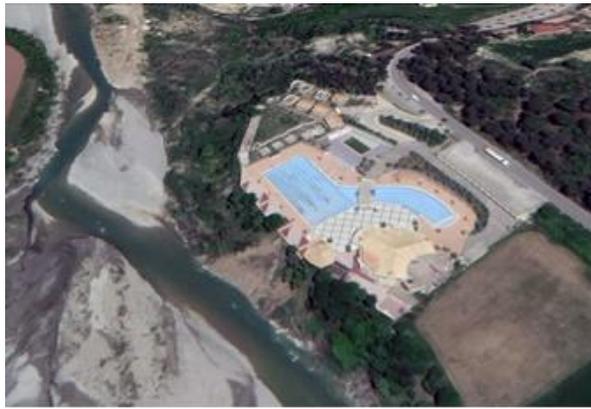
The area along the Erzeni River is an area with great tourist potential. There are many restaurants, hotels, swimming pools, etc., which give very good contribution to the economic development but need to be careful on water discharges.

Fig 5. Swimming pool near to the river [Source: Google earth]

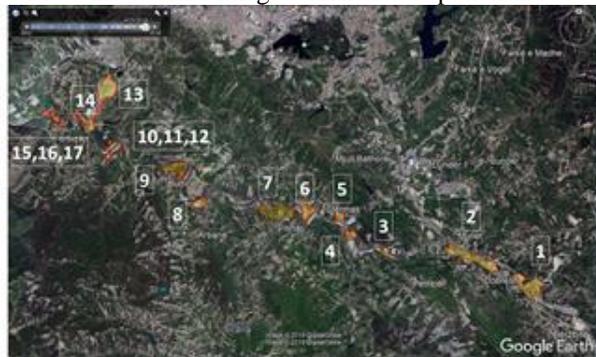
As a result of field work and imagery processing there are identified 17 damaged zones, numbered 1-17. In most of them the pollution source is industry and machinery for construction materials, inert. The others pollution source are villages, resorts, swimming pools, parking, oil deposits, landfill, etc. Fig.6 shows the satellite image with zones of pollution.

Fig. 6 Satellite image with damaged zones [Source: Image Google earth]
